**Vantage Pointe Condominium Corporation
Parkade**

Plan No: 0510908

**2017 Capital Replacement Reserve Fund
Study**

Wall Engineering Ltd.

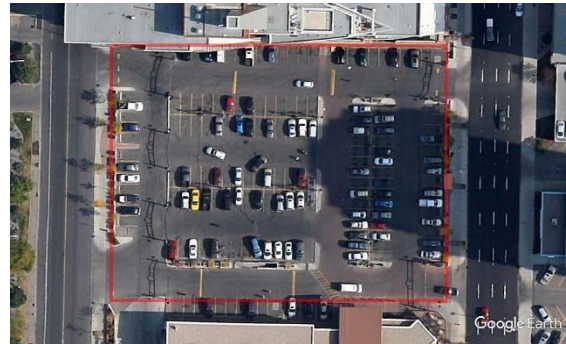
The roof over the parkade consists of a built up waterproofing, with asphalt wearing surface, and the area is used as exterior/surface parking for the adjacent CO-OP building.

Photograph 1: Parkade Roof.

We recommend performing annual roof inspections as part of a preventative maintenance program and that the remaining life of the roofing be revised based on the results of the review and maintenance requirements. If any evidence of moisture infiltration is identified, remedial repairs should be initiated promptly to mitigate damage. Preventative maintenance measures should include cleaning and removal of debris from drains, sealant application to open joints or failed seams.

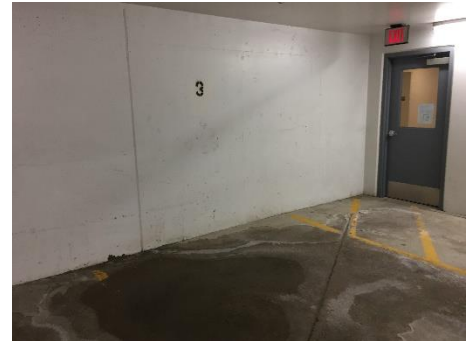
Photograph 2: Painting Finishes and Doors

The parkade entrance/exit high speed fabric doors as well as the common area, service room and stairwell doors have been included in the reserve fund. No budgets have been included for replacement of the handrails within the stairwells at this time.

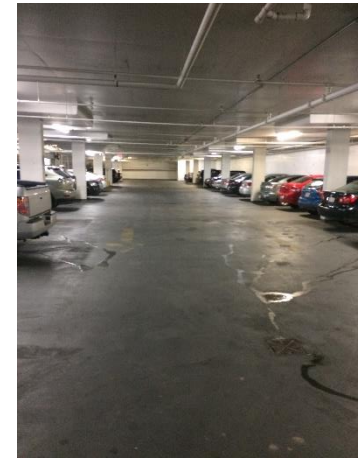
Photograph 3: Parkade Level.

The slab-on-grade parkade floor positively slopes towards the drains, and control joints have been installed to promote and control cracking from normal concrete shrinkage. Replacement of the structural components is not typically performed and budgets have not been carried in the study. We have included a partial allowance for select concrete replacement, which would typically include replacement of damaged exposed concrete finishes, spalling/delamination and general surface scaling.

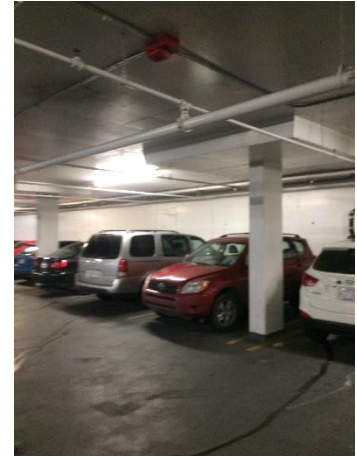
Photograph 4: Parkade Level.

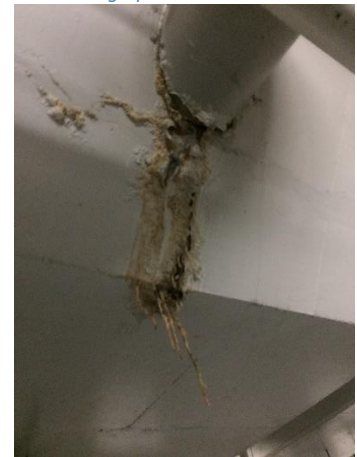
The storm and sanitary services consist of the underground lines that could be constructed of concrete and/or cast iron, which can deteriorate over time. Visual inspection of these underground services was not performed as part of this report. Typically, the sewer piping will not require complete replacement. We have not allowed for full replacement of the various underground service lines at this time; however we have provided an allowance for selected repair/replacement of lengths of pipe. Should repairs become significant or too frequent, replacement of the systems could be required.

Photograph 5: Surface Lot Drainage.

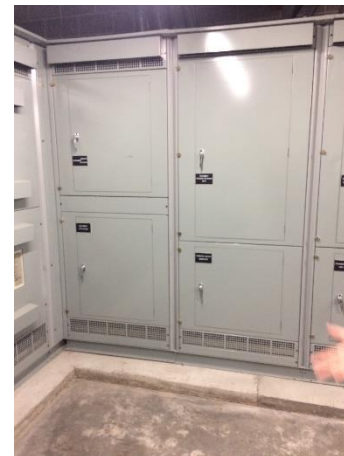
Photograph 6: Parkade Level.

A proper preventive maintenance schedule typically includes periodic cleaning and infrared scans of all panel, disconnects, motor starters and distribution centers. It is recommended that this practice be implemented. In addition, it would be anticipated that such a maintenance program would need to be increased in frequency as the buildings age.
